Appendix C: Photographs of Adjacent Properties in the APE

DPR 523A & 523B Forms for Properties over 45 Years Old within the APE

Historic Resource Inventory and Evaluation Report, Martinez Senior Apartments
Carey & Co., Inc.

*P11. Report Citation: Carey & Co., Inc., "Historic Resource Inventory and Evaluation Report, Martinez Senior Apartments, 310 Berrellesa Street, Martinez, California," 17 February 2009.

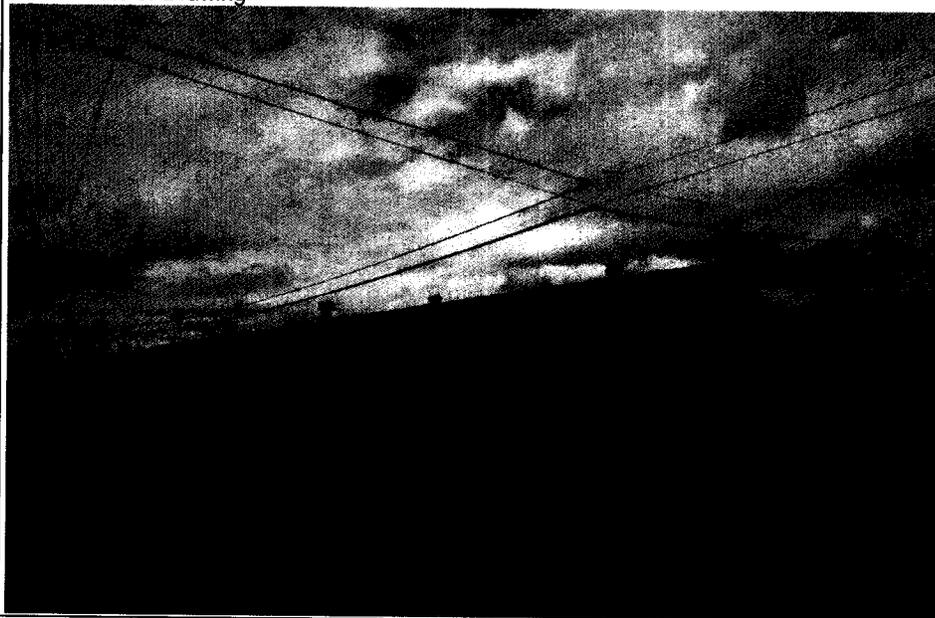
The parcel addressed as 300 Alhambra Street contains three commercial buildings constructed in 1948 lining its west, north, and east boundaries. The buildings surround a central paved parking lot, while a metal fence encompasses the parcel. (See continuation sheet.)

P5b. Description of Photo:
View north toward the parcel's
western commercial building;
February 5, 2009

The western building is a one-story, rectangular-in-plan structure with a concrete foundation. Corrugated metal clads both the building and its steeply-pitched, side-gable roof, which has a wide eave overhang and metal brackets in the gables. The façade faces east toward the parking lot and contains large garage entrances along with 6-lite, industrial-sash awning windows. The north and west elevations feature similar 9-lite, industrial-sash windows with operable ventilators. The south elevation contains an expanse of T1-11 cladding and no fenestration.

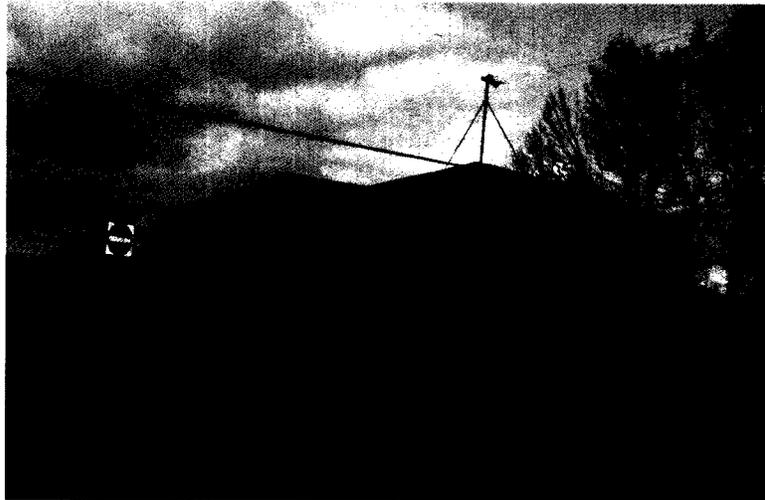
View northwest toward the western building (Carey & Co., Inc., February 12, 2009).

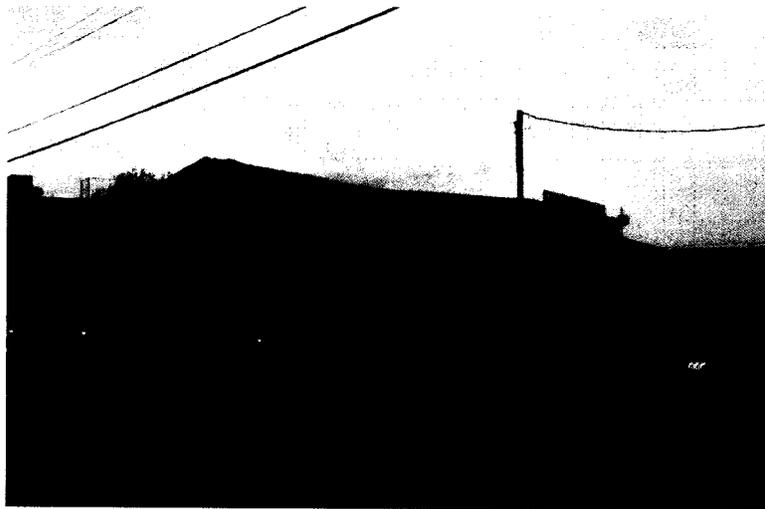
Although smaller in length and width, the northern building is similar to the western building in plan, height, cladding, roof configuration, and fenestration. Its roof also features a wide shed dormer.

View north toward the northern building (Carey & Co., Inc., February 5, 2009).

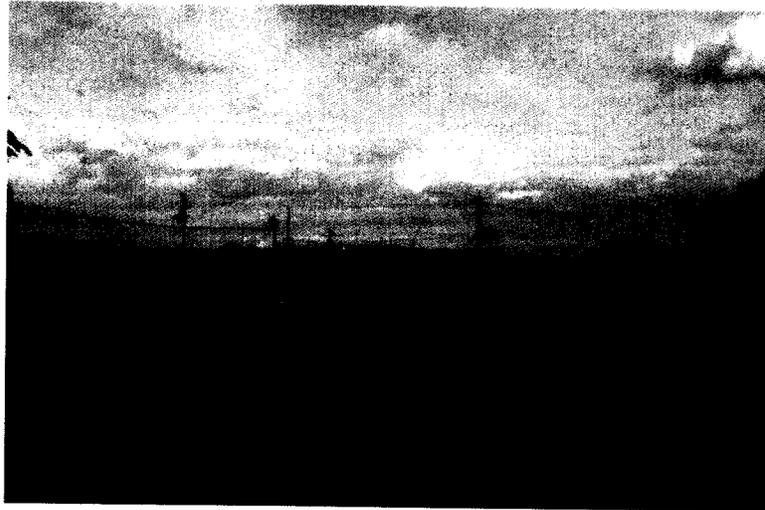
Garage: Constructed on the parcel between 1950 and 1959, this one-story garage has a rectangular plan and a concrete foundation. The front-gable roof clad in rolled asphalt sheets terminates in a wide eave overhang with exposed rafter tails. Plywood boards clad the structure. The easterly-facing façade contains a large garage opening, while a wood-frame, flat-roofed addition projects from its north elevation. The west and south elevations are devoid of fenestration.

View of the garage's west and south elevations from Richardson Street
(Carey & Co., Inc., February 5, 2009).
