CITY OF MARTINEZ

SUBJECT: Authorizing Emergency Work to Stabilize Alhambra Creek Bank

(ALHAMBRA CREEK, ESCOBAR TO MARINA VISTA)

PROJECT NO. C3007

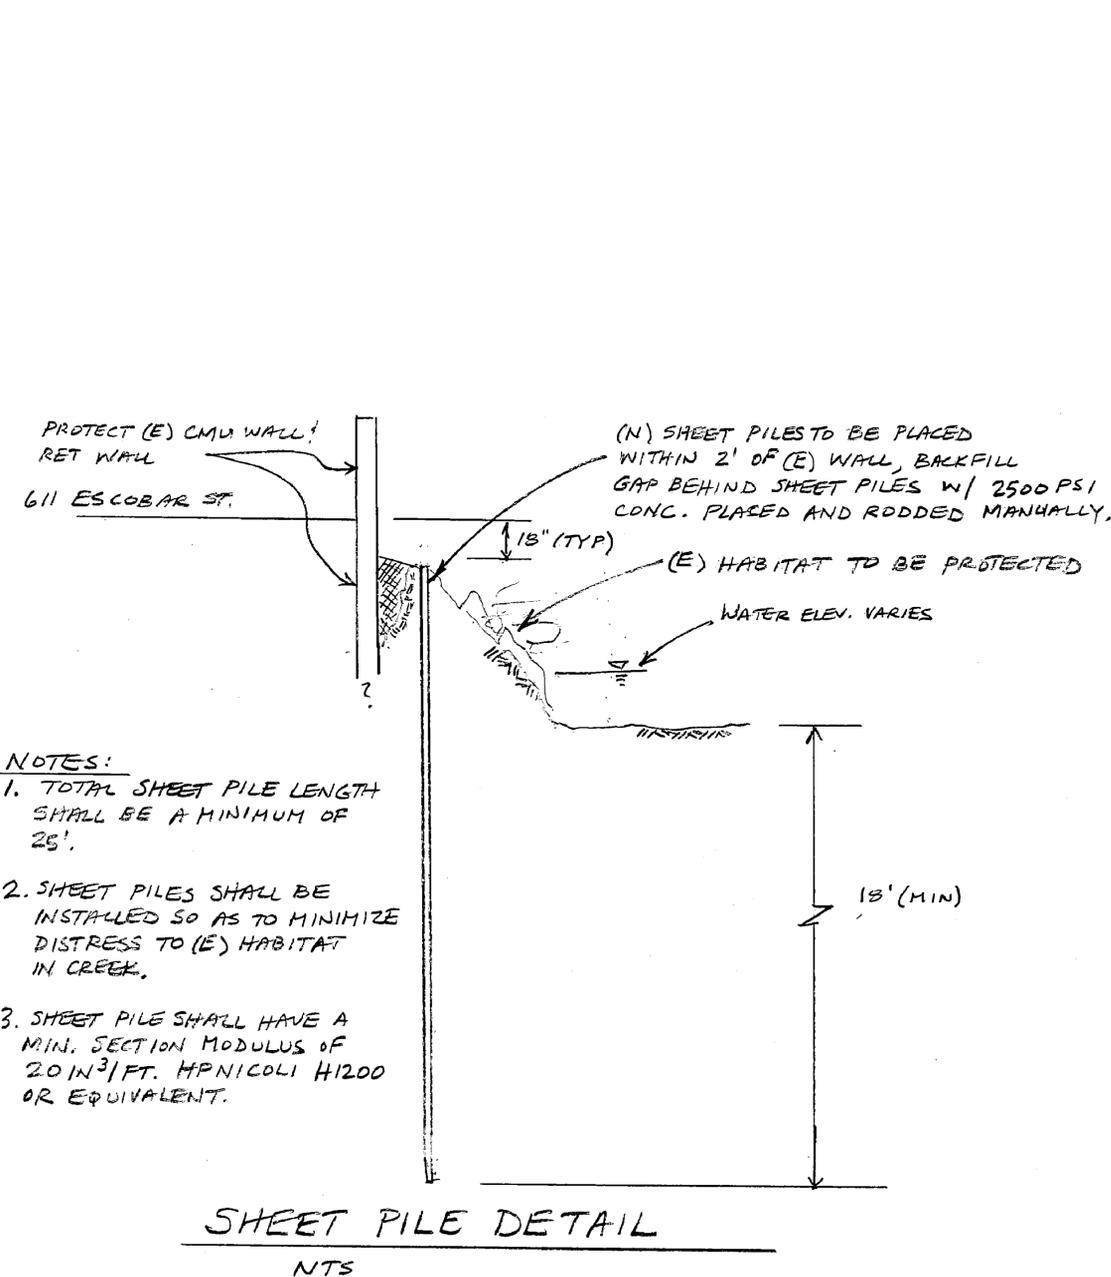
1. TOTAL SHEET PILE LENGTH SHALL BE A MINIMUM OF 25'.
2. SHEET PILES SHALL BE INSTALLED SO AS TO MINIMIZE DISTRESS TO (E) HABITAT IN CREEK.
3. SHEET PILE SHALL HAVE A MIN. SECTION MODULUS OF 20 IN³/FT. HPN100L1 H1200 OR EQUIVALENT.

- H. Install bulkhead walls at the top of bank.
- I. Install local bio-technical improvements for re-vegetation purposes.
- J. Fill in beaver burrows with pressure grout.
- K. Install sheet pile walls.

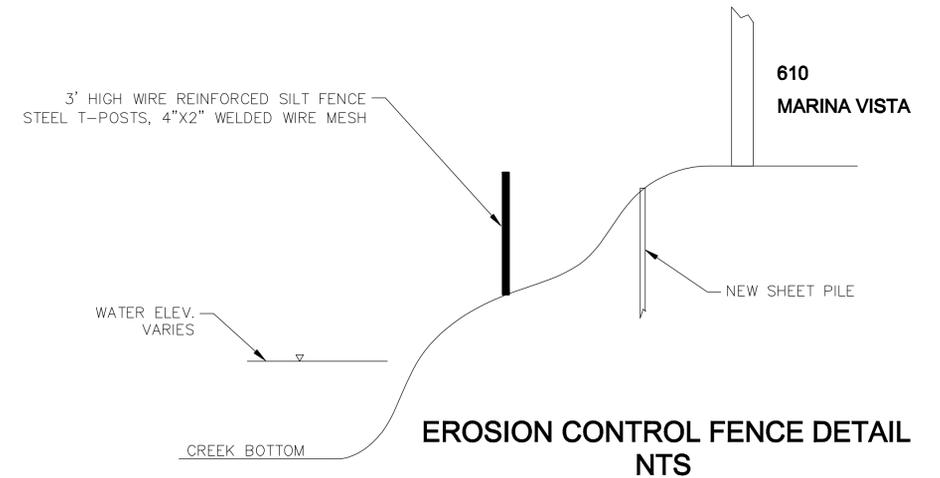
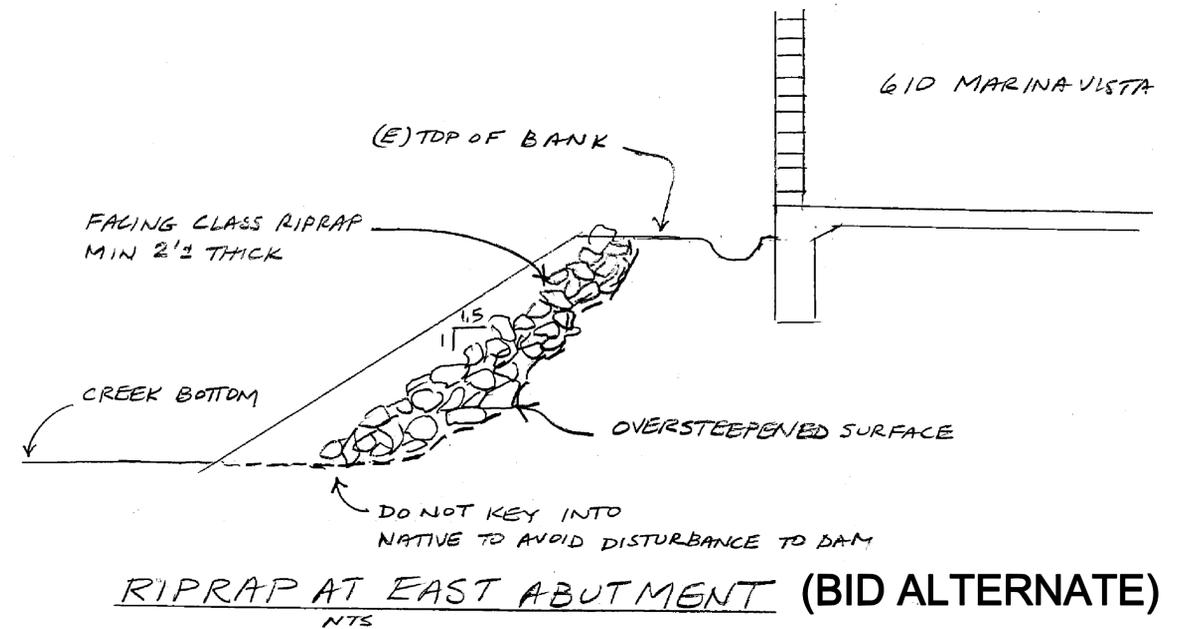
- NOTES:**
1. MANUALLY GRUB AREA TO REMOVE BRUSH AND ROOTS GREATER THAN 1" IN DIA.
 2. MANUALLY PLACE FACING CLASS TO AN INCLINATION OF 1.5:1 OR TO CONFORM AT ENDS.

- A. The properties along the east side of Alhambra Creek from Escobar to Marina Vista are being adversely affected by the ongoing beaver activity.
- B. The increased risk of flood problems and related problems is significant.
- C. The primary geotechnical concerns are erosion and bank stability.
- D. Erosion and bank stability have reached critical levels with local undermining of adjacent walls and structures.
- E. Seismic risks are present due to erosion and stability the creek bank.
- F. Remove and relocate of the beaver colony to a more suitable habitat niche in a natural setting.
- G. Install rock revetments using large dimension boulder riprap.
